POPPLETON HISTORIC STUDY

B-2573

<u>Block</u>	<u>Lot</u>	<u>Address</u>
202	29-33	13-21 Schroeder Street

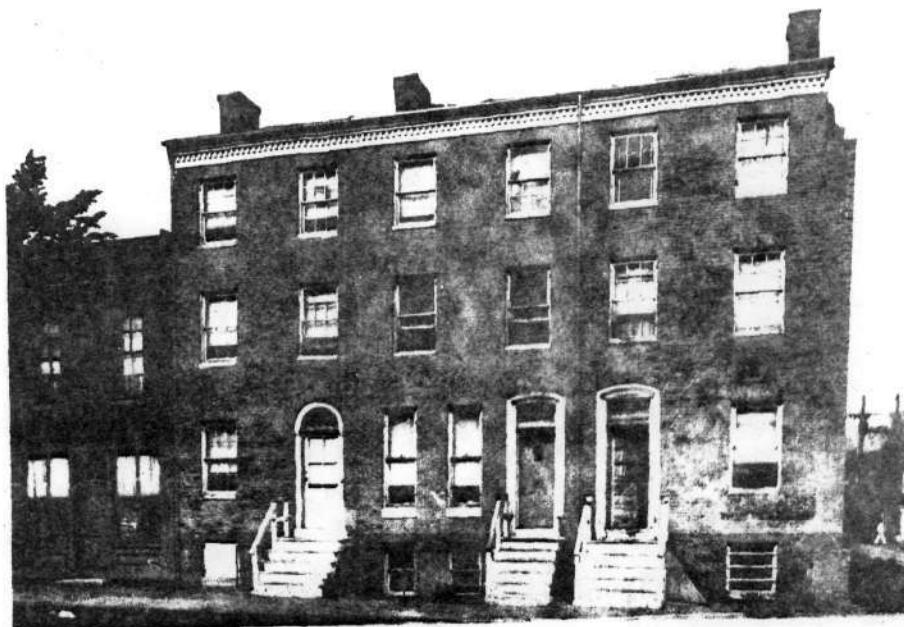
B-2573

The map of 1852 shows numbers 15, 17 and 19; they are a late carpenter Georgian style. Number 21 was built as a shop with one story above; it is also a deeper building. The structure which was on lot 29 was also deeper than 15, 17 and 19, and may also have had a shop beneath it. Map of 1876 shows all four. Numbers 15-19 have gable roofs. Number 19 has a round-headed door which is common on some better houses of this period in the area. There are 6/6 windows remaining at 15 and 19.

The house at 13 has been demolished. Street is wide; street trees are needed; land opposite has been cleared. These houses are of strong enough character to stand alone.

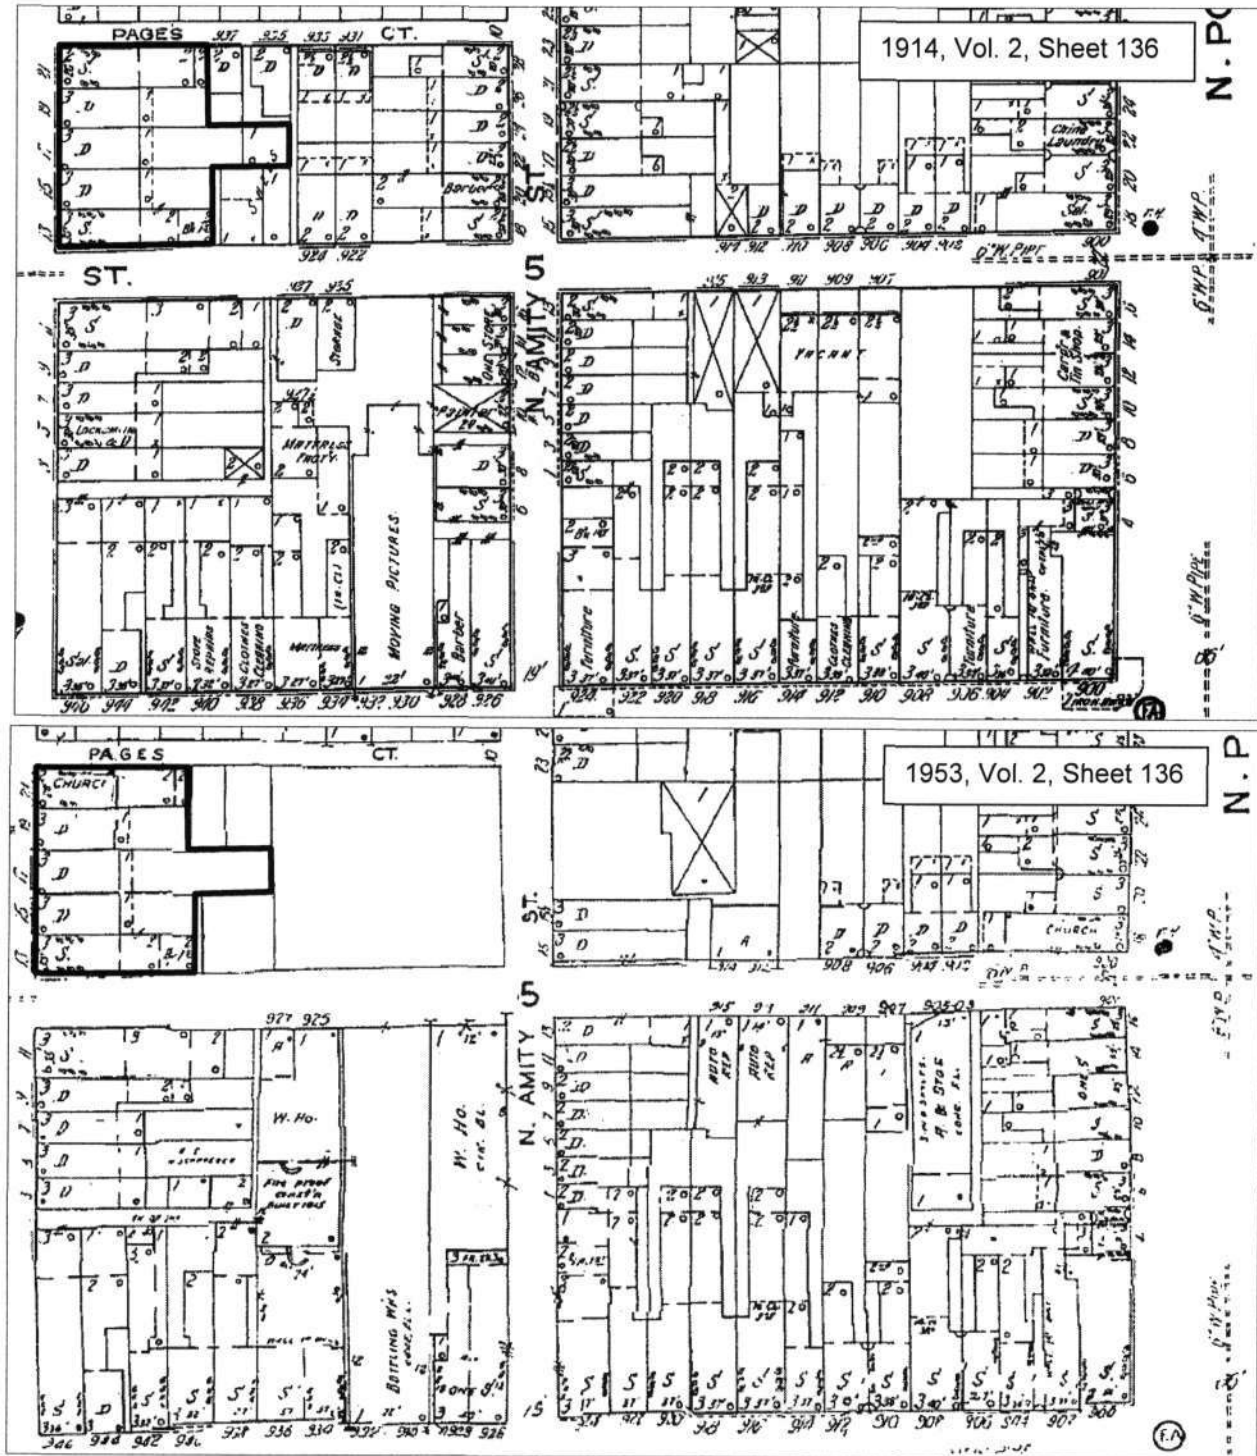
Sanborn Maps

13-21 N. Schroeder Street (13-19 Demolished)
